## **5.6 City of Hialeah**

## 5.7 City of North Miami

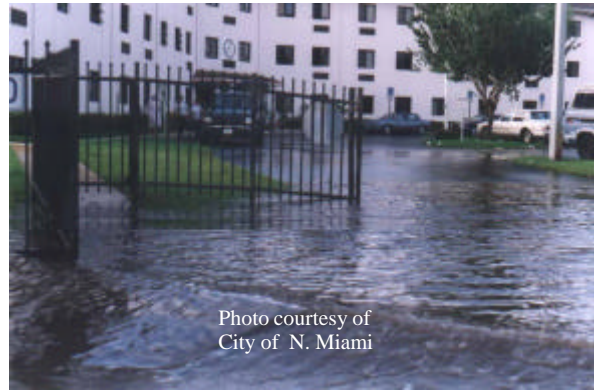
Power failure occurred at Stormwater Pump

Station E, located at NE 12<sup>th</sup> Ave. and NE 143 St., a back up CNG pump could not keep up with the flows. Within twenty-four hours of power restoration most of the affected areas were dry or pumped out. Consequently, the Ruck's Park Pump Station service area was dry within twenty-four hours after the power was restored.
